# Simultaneous Bilateral Traumatic Tibial Post Fracture in Total Knee Arthroplasties: A Case Report

Ganesh Balendra Andy Williams

Fortius Clinic, London, UK

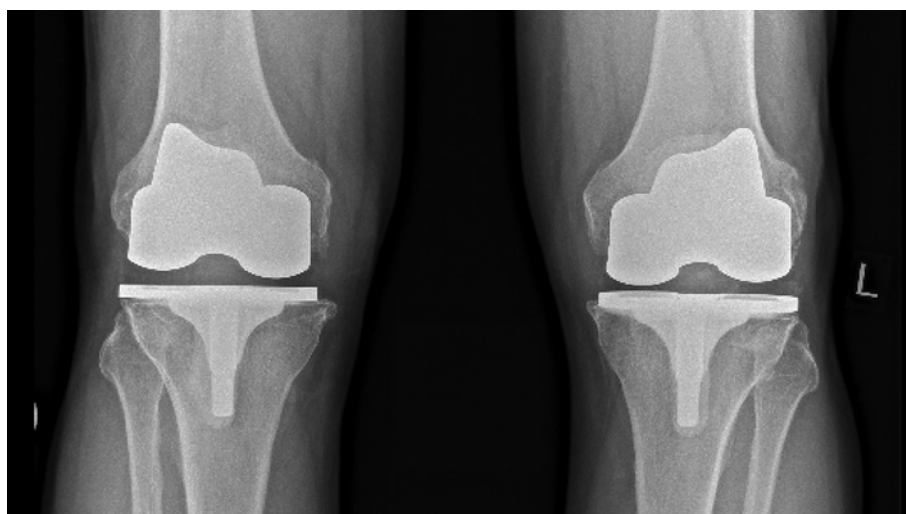
Radiographs showed well-aligned prostheses with no signs of loosening, but some patellar wear especially the lateral facets (Fig. 1, 2). MRI scans showed, in both knees, erosion of the lateral facets of the patellae, and in the right knee showed what appeared to be a loose body and the senior author considered the possibility of a broken-off bone cement fragment (Fig. 3). The patient was offered bilateral patellar resurfacing in view of the anterior knee pain preceded by arthroscopy of the right knee to ensure localization and removal of the loose body, which can be difficult with open surgery if the loose body has moved to the posterior recesses of the knee.

Fig. 1. AP X-rays of both knees.

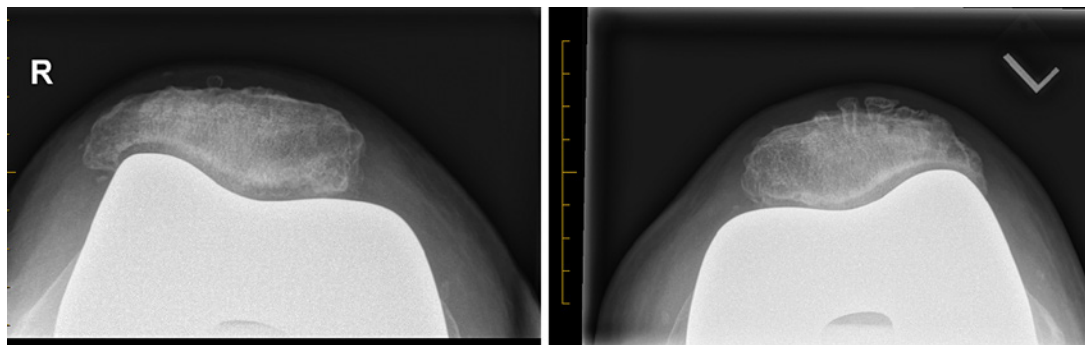
**Fig. 2.** Axial X-rays of both knees.

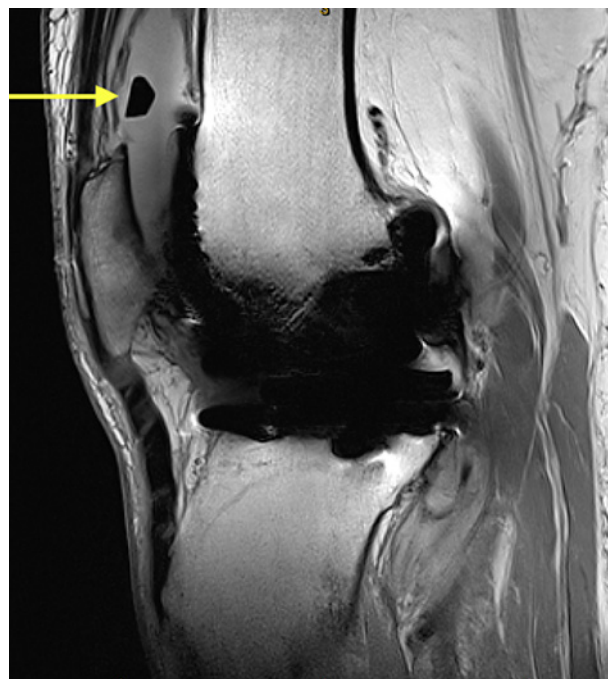
**Fig. 3.** Sagittal MRI of right knee. Fractured tip indicated by arrow.

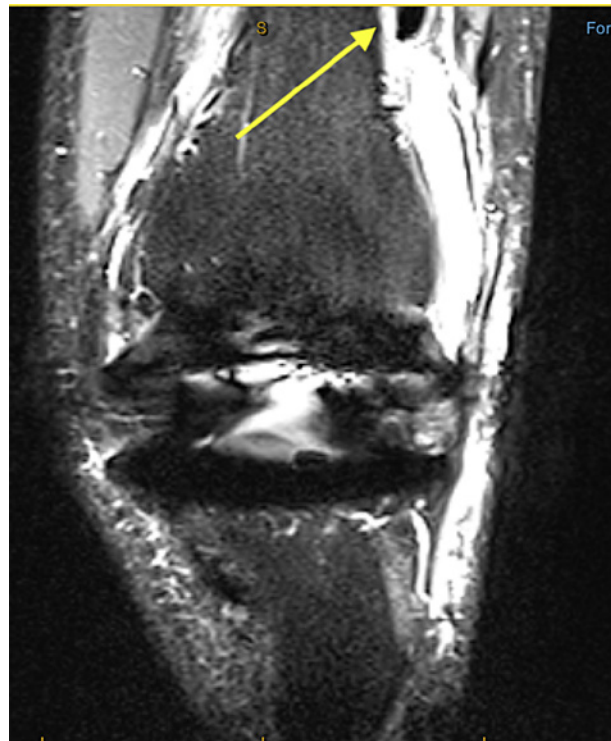
However, with review the evening before surgery, a similar loose body was partly visualized at the edge of an image in the left knee (Fig. 4). On the morning of surgery, the patient

**Fig. 4.** Coronal MRI of left knee. Fractured tip indicated by arrow.

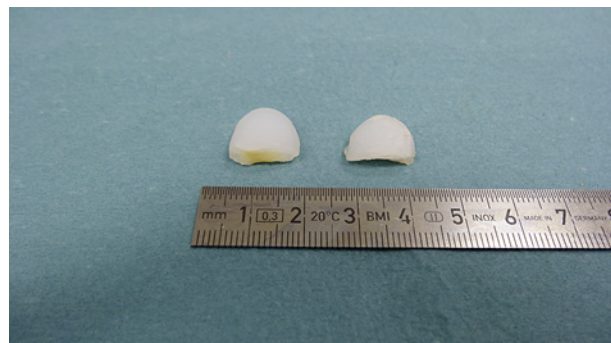
During the arthroscopies in January 2020, the true diagnosis was made. It was confirmed that in both knees there was a fracture of the polyethylene post close to the tip. The fractured post tips were found in the lateral gutter in the right knee and the suprapatellar pouch in the left knee and removed (Fig. 5). In the left knee, the “loose” body was embedded in synovial tissue which accounted for the lack of swelling, locking, and sharp pain. Open resurfacing of both patellae was undertaken. This allowed thorough examination of the prostheses. The original components were well fixed in both knees, and despite the post fractures with consequent loss of their height, the knees were stable on stress testing in both AP and ML directions, and it was not possible to distract the joints sufficiently to allow the femoral components to “jump” over the remaining polyethylene posts. The rest of the polyethylene was healthy. Prior to surgery direct contact with the TKA manufacturer was made and the senior author was told that since the Journey I prosthesis has been super-

**Fig. 5.** Clinical photograph of fractured tips.

The operative findings were fortunate as any need to revise the polyethylene components would have entailed a complete revision of all components, and thankfully, a decision could be reasonably made to retain the original polyethylene components. The patient has been warned of the risk of future episodes of instability. The patient recovered well from surgery and was discharged home 2 days later. At his 12-month follow-up, the patient reported complete resolution of symptoms.
